# HOME INSPECTION REPORT

12345 Street Name, City Zip Code

**Inspection Date:**

2/17/2007

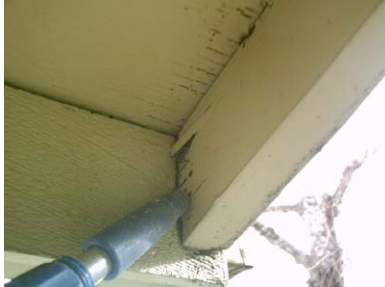
Fungal rot was found in the fascia board and roof sheathing of the NE corner of the building...recommend removal and replacement of all damaged materials.

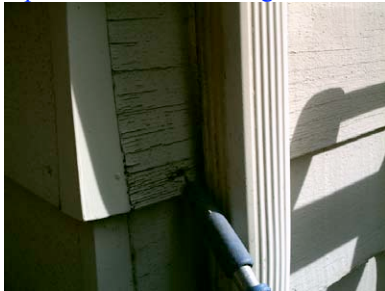
Fungal rot was found on the siding near the downspout on the SE corner of the building...recommend removal and replacement of all damaged materials.

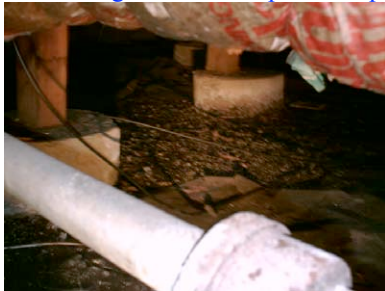
There is no vapor barrier installed in the crawlspace area...recommend installation to prevent ground moisture from condensing in the crawlspace and potentially causing damage to the structural members.

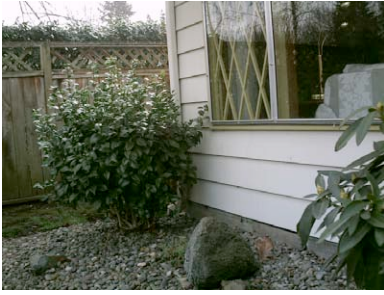
The bush on the SE corner of the building is in direct contact with the siding...recommend keeping all bushes and shrubs trimmed at least 12" away from the building to allow adequate air circulation to prevent moisture damage to the siding materials.

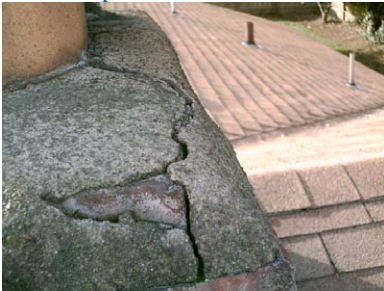
There are visible cracks in the crown of the chimney...recommend an evaluation by a licensed chimney technician to prevent moisture penetration into the chimney chase.

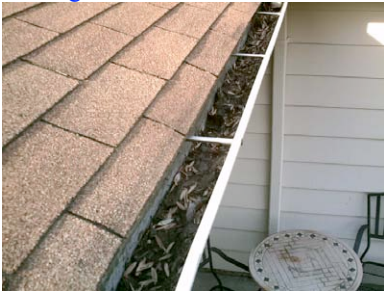
The gutters are filled with debris from the adjacent trees...recommend cleaning the gutters and downspouts to allow proper drainage.
