# HOME INSPECTION REPORT

12345 Street Name, City Zip Code

**Inspection Date:**

2/17/2007

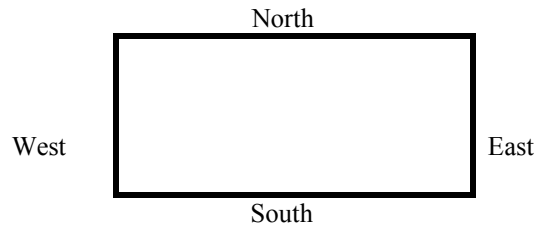
**BASEMENT/CRAWL SPACE WALLS**  
 Diagram indicates where wall not visible and type of covering:  
 P = Paneling C = Crack(s)  
 D = Drywall M = Monitor  
 S = Storage E = Evaluate  
 O = Other

There is no vapor barrier installed in the crawlspace area...recommend installation to prevent ground moisture from condensing in the crawlspace and potentially causing damage to the structural members.
